Aug 21st, 2025

# Home Inspection Report

Corey Hinson / Cornerstone Home Inspections

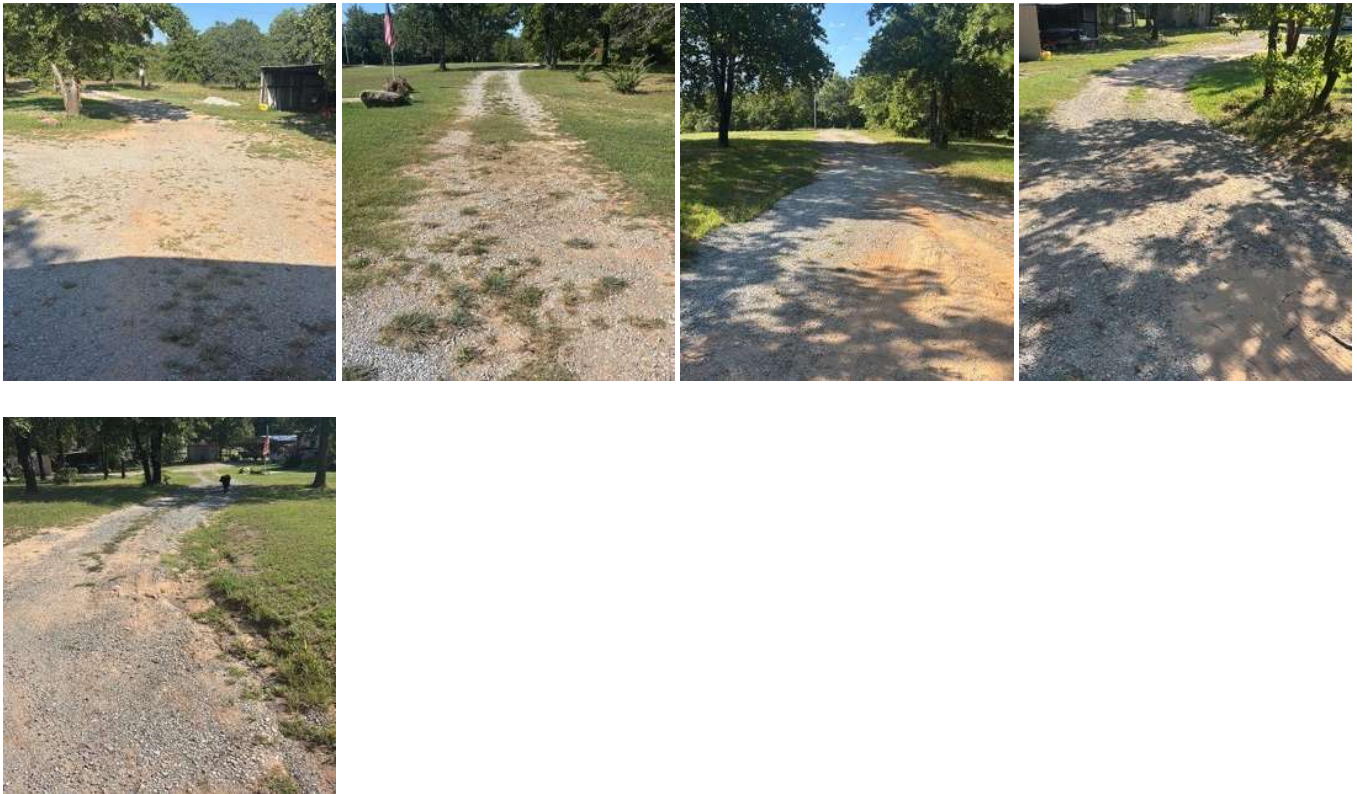
**Driveway on Slope. Regular maintenance needed**

The driveway is situated on a slope, which requires regular maintenance to ensure proper drainage and to prevent erosion or surface damage. Monitor for any signs of material displacement. Consider installing a drainage system to divert water away from the driveway. Regular inspections are advised to address potential issues early.

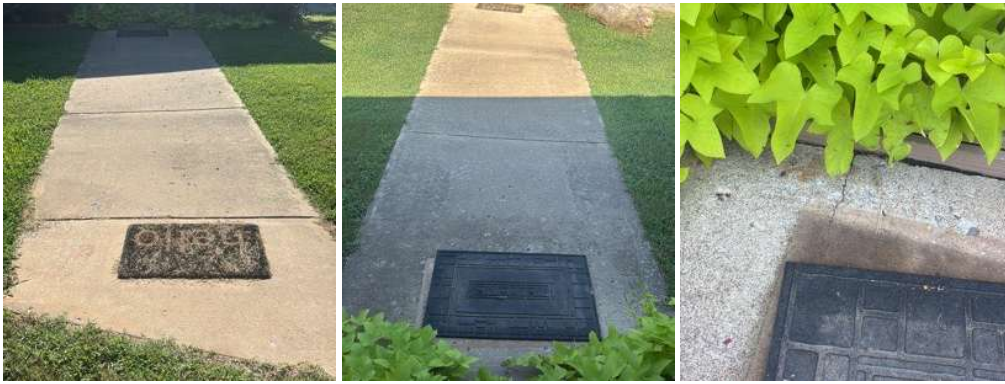
Cracks found

Cracks were observed in the walkways, which may indicate settling or underlying structural issues. Recommend monitoring for further movement and consulting a professional to assess and repair as needed to prevent potential hazards.

Concrete pitted and chipped

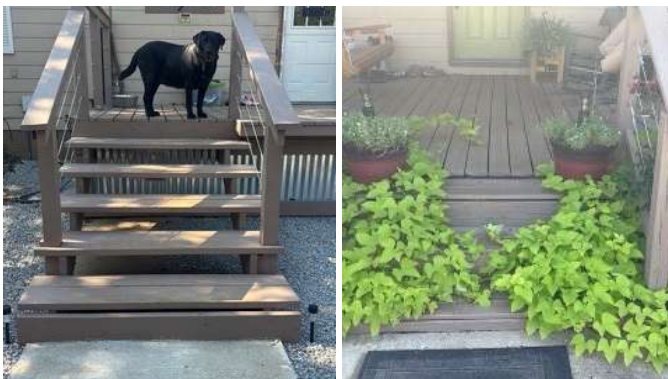
Location - West

vegetation

Vegetation observed near steps/stoops can cause damage and pose a safety hazard. Recommend removing vegetation to prevent structural deterioration and ensure safe access. Regular maintenance will help preserve the integrity of the area.

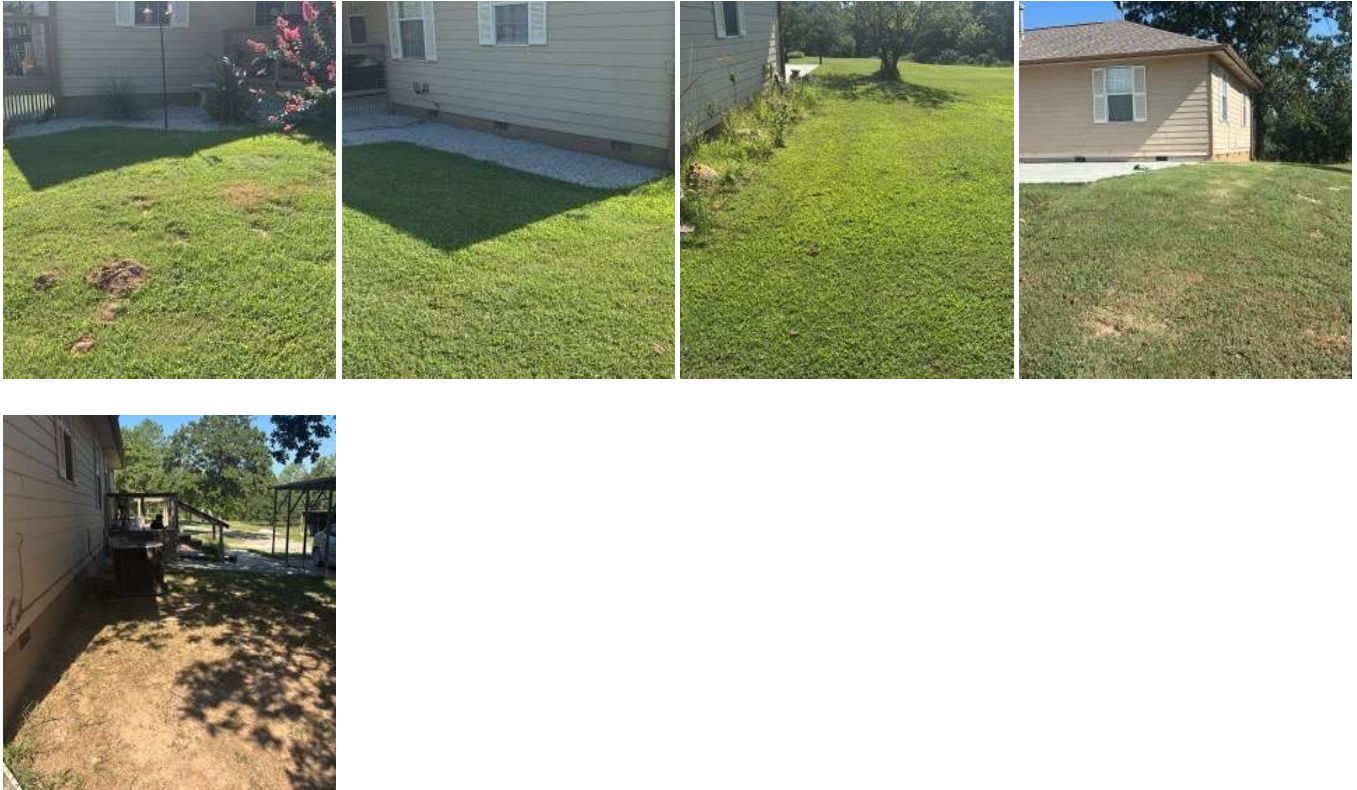
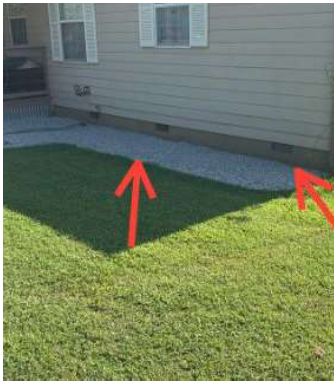
Location - Southwest

Improper slope is draining water towards the foundation which contributes to moisture and water penetration in the basement

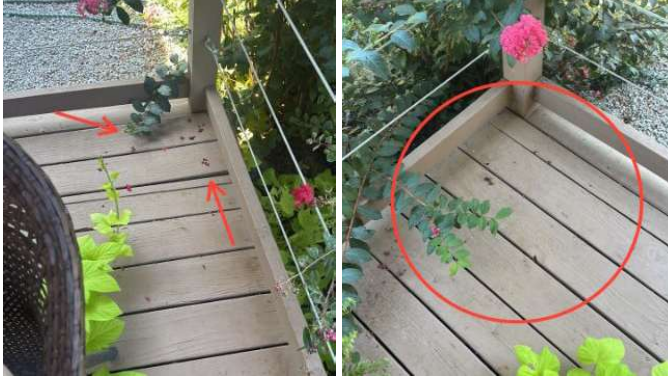
Location - West

Boards are no longer fastened to structure

### Trip hazard

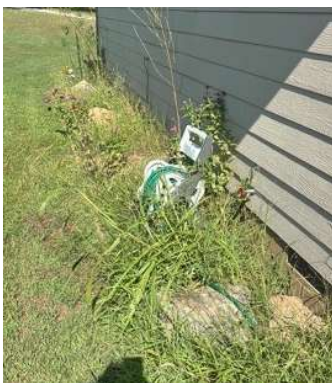
vegetation

Vegetation observed growing too close to the structure may lead to moisture intrusion and pest concerns. Trim back or remove plants to at least 1-2 feet away from the exterior walls to maintain proper airflow and reduce potential damage. Regular maintenance is advised.

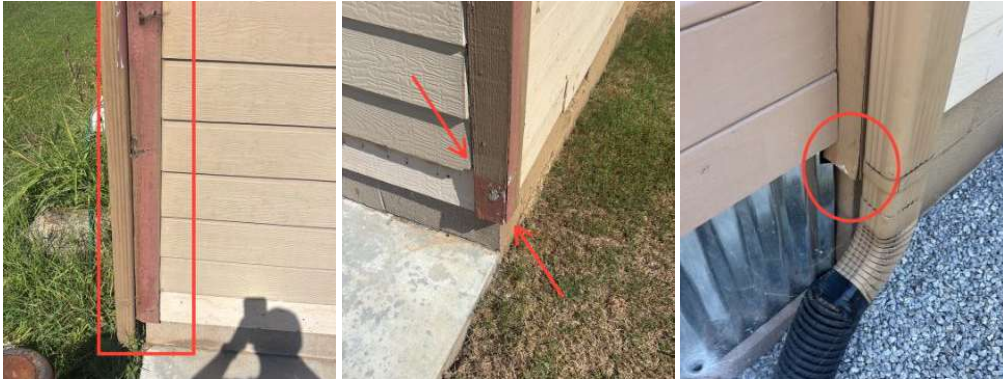
Location - Northwest, Southeast

### Rot noted

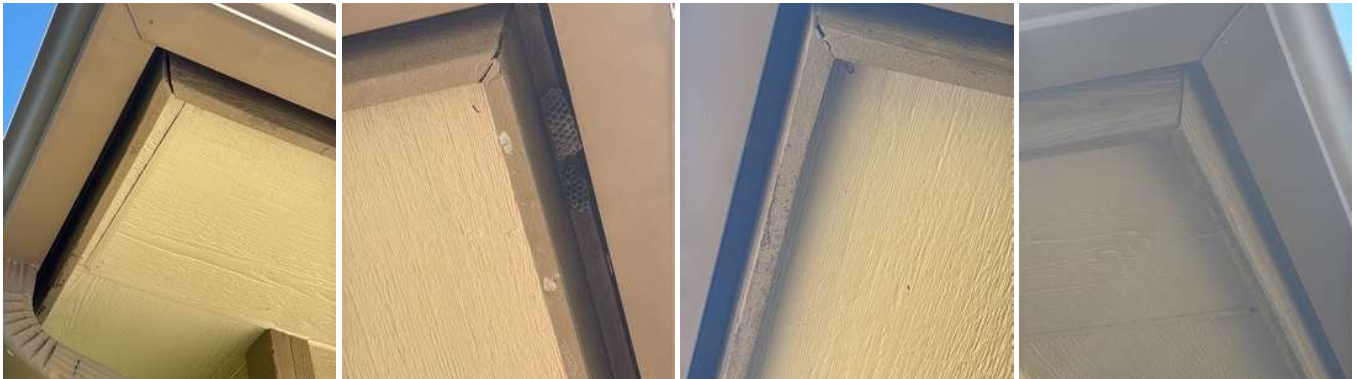
Location - North, South, East, West

Recommend painting/caulking wood finish

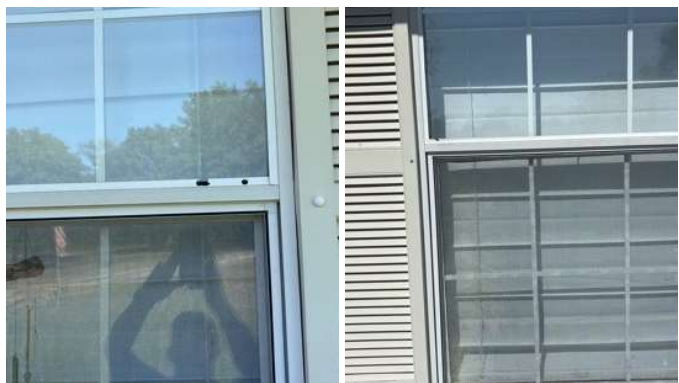
Location - East, West

Window seal broken or damaged

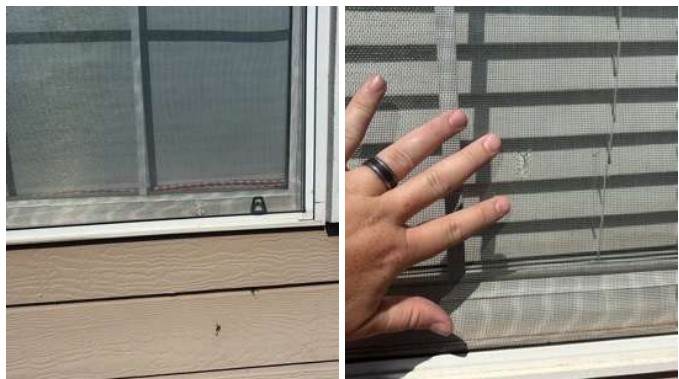
Location - East

Screens torn/damaged

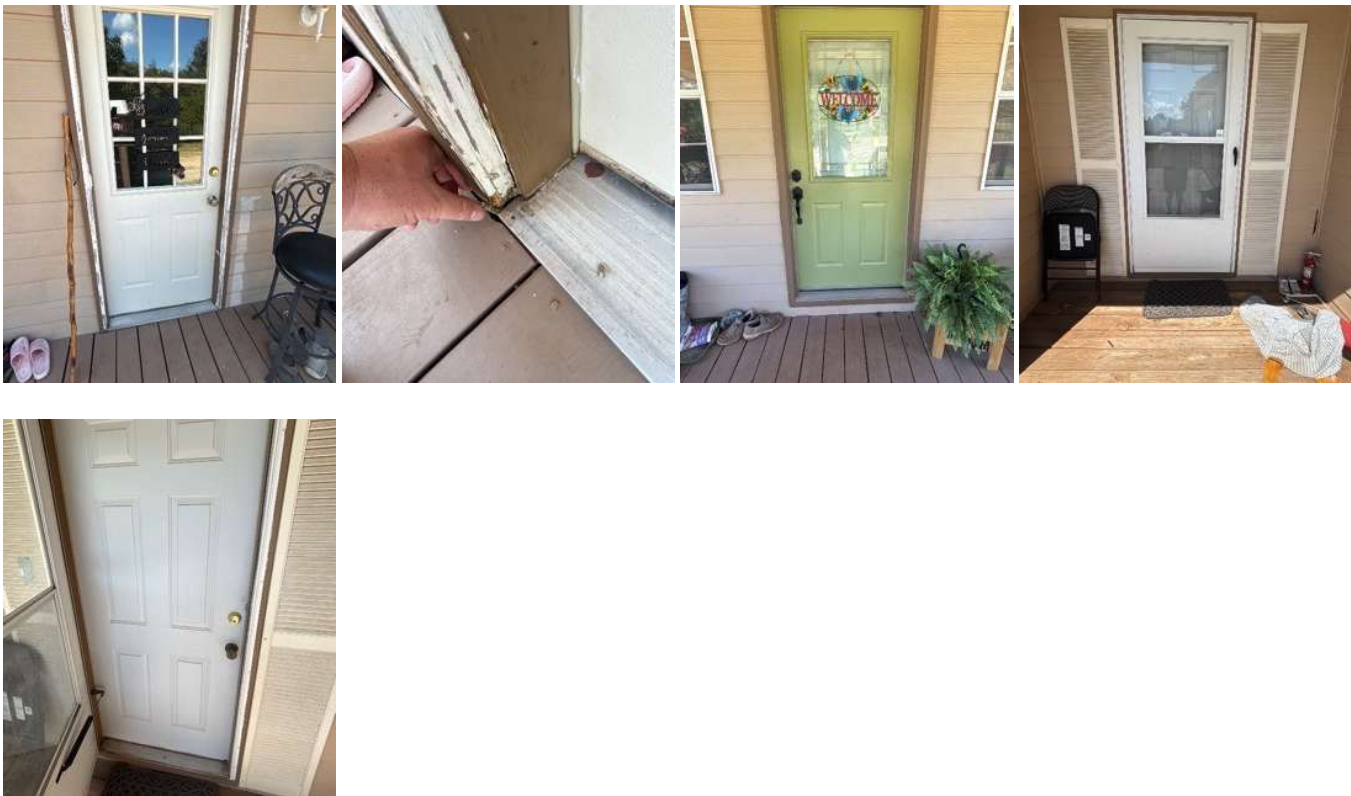
Location - North

Paint peeling

Wood rot

Recommend that a qualified contractor evaluate and estimate repairs

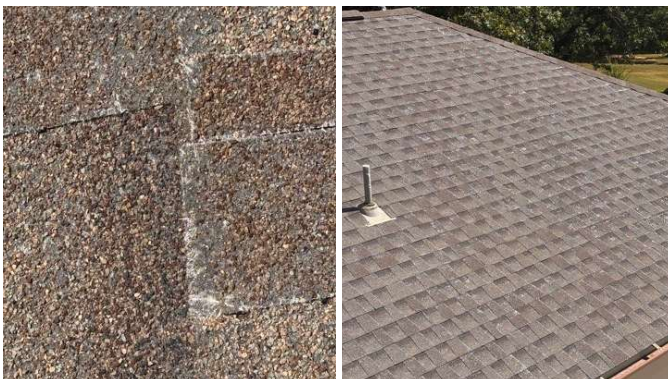
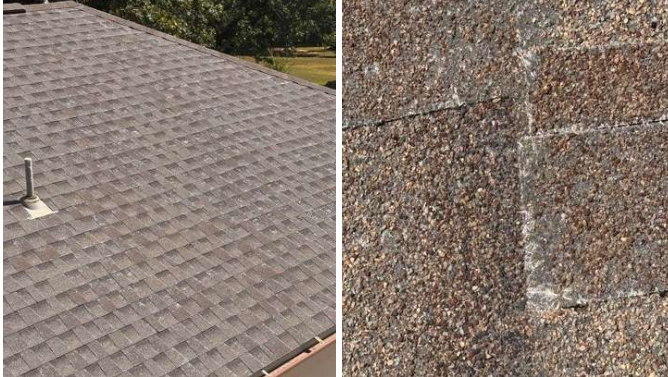
Roof at/near end of useful life

Recommend that a qualified contractor evaluate and estimate repairs

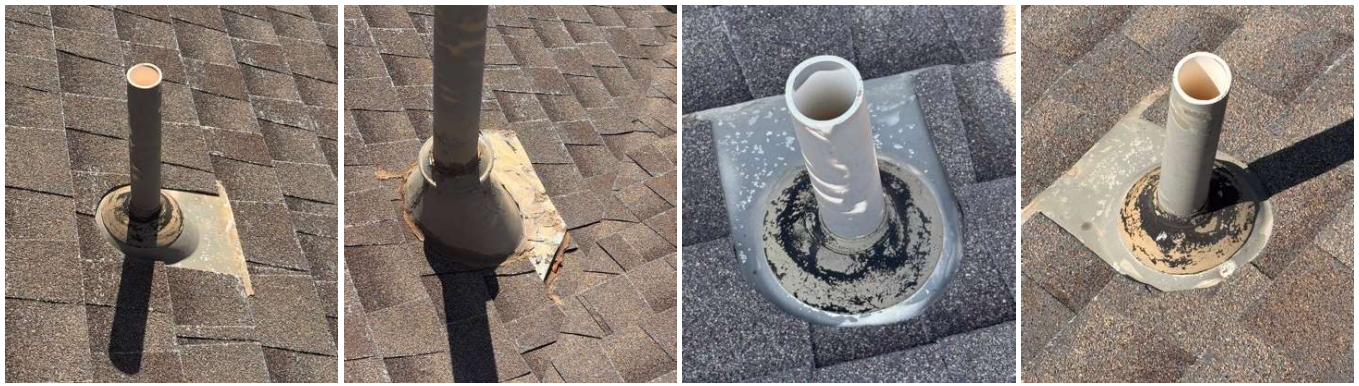
Monitor the boot or flashing at the vent pipe

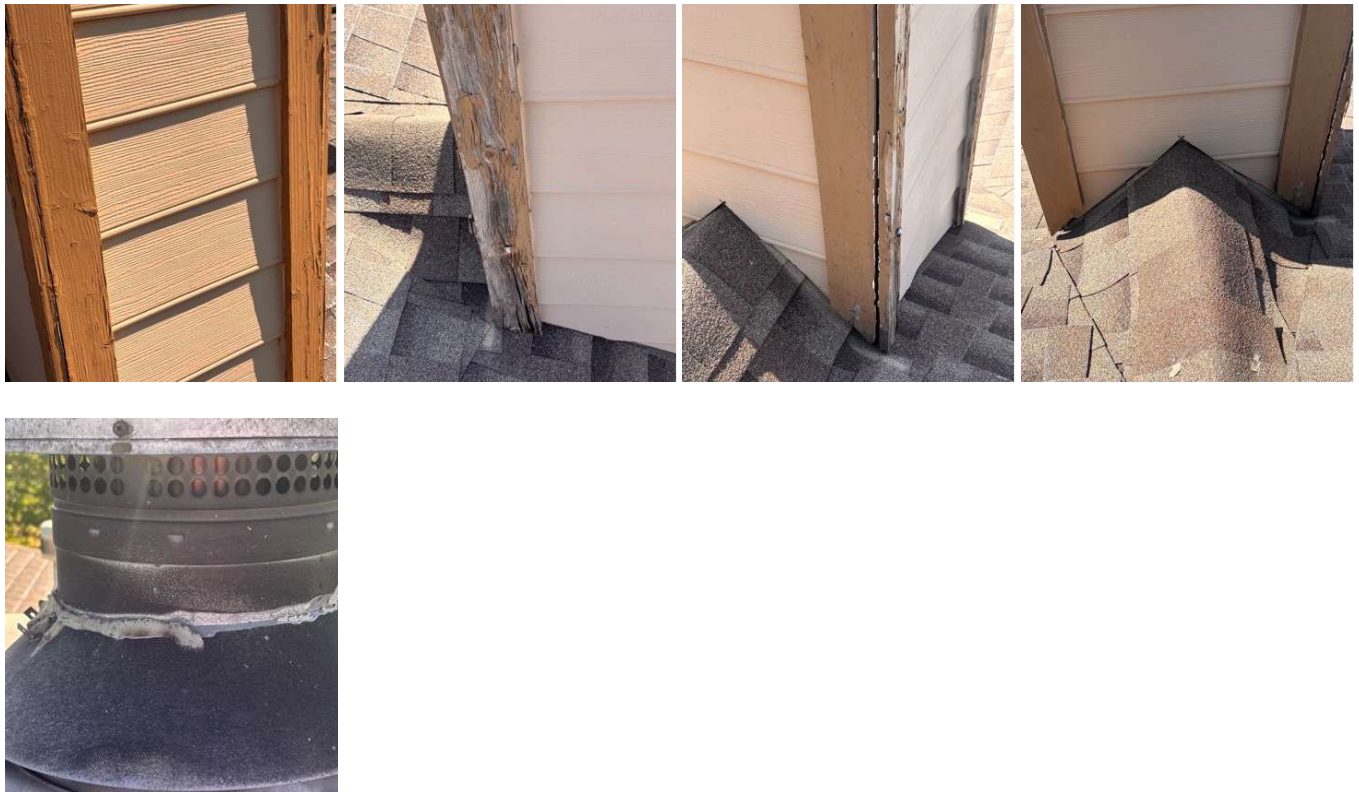
#### Siding is rotting and pulled away

During the inspection, I observed that the siding surrounding the chimney is rotting and has pulled away from the structure. This damage can lead to water intrusion and further deterioration of the chimney and siding. I recommend consulting with a licensed contractor to repair or replace the affected siding sections. Addressing the issue promptly will help prevent additional structural damage and potential water-related issues.

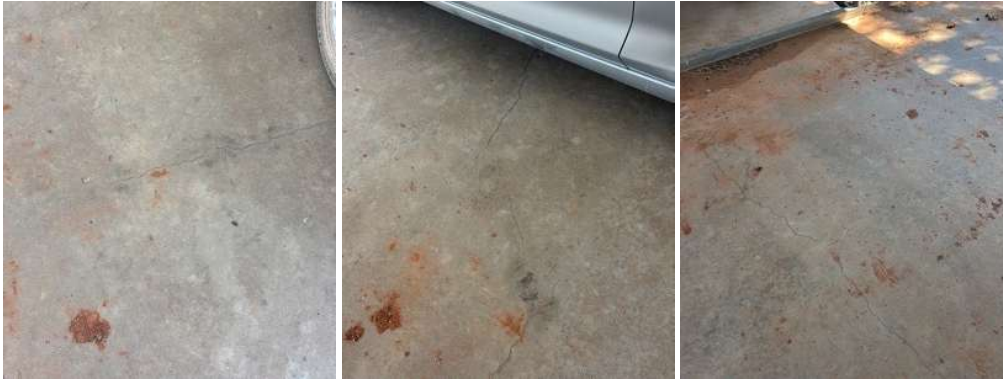
### Minor floor crack(s)

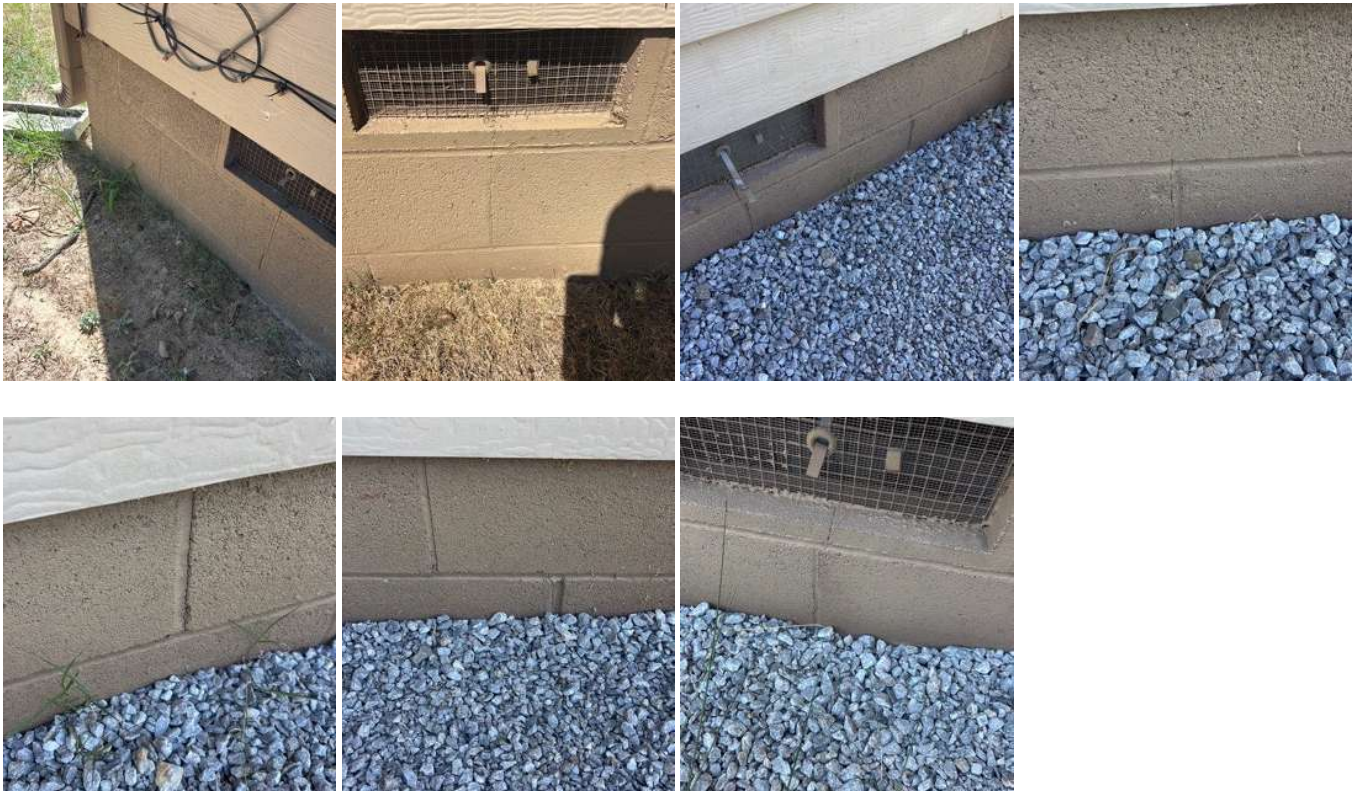
Cracks present but not active

During the inspection, non-active cracks were observed in the foundation. These do not appear to currently indicate any structural issues. It is recommended to monitor these cracks over time for any changes or signs of movement. Consult a structural engineer if any crack activity is noted in the future for a detailed assessment. Regular maintenance and moisture management can help prevent further cracking.

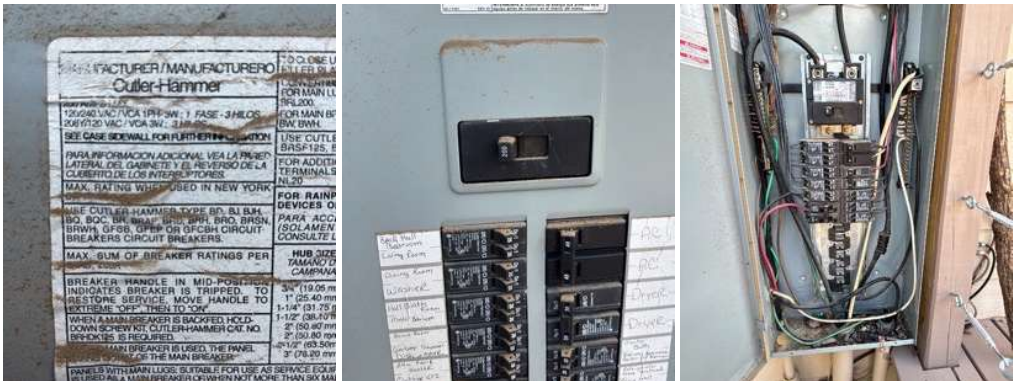
Open knockout hole. Insert blank to cover opening.

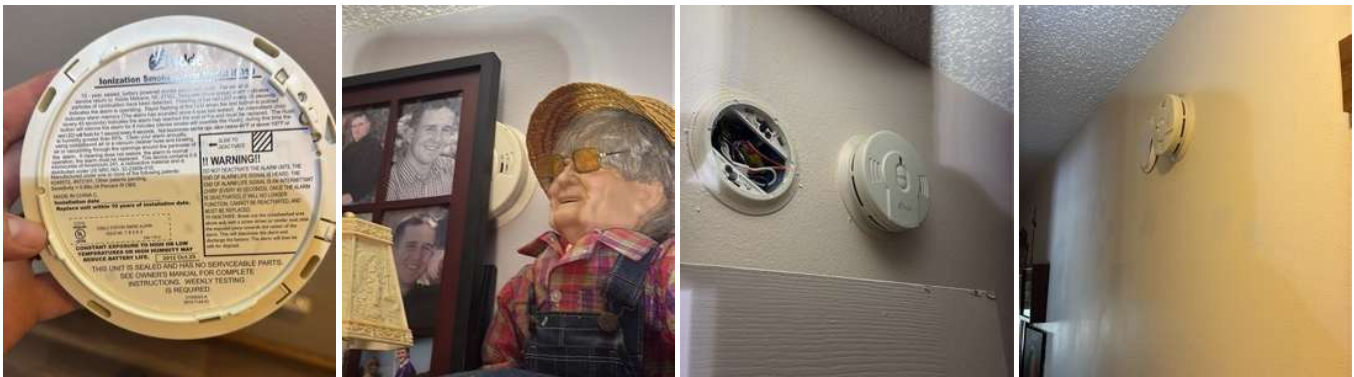
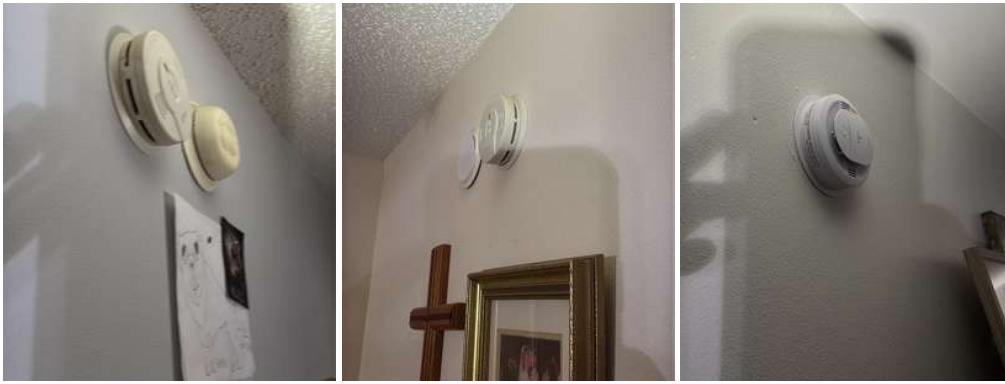
Location - Bedroom, Living room, hallway

**INFORMATION:** Master bedroom appears to be the only updated smoke detector no install dates written recommend replace every 10 years

Recommend that buyers install new smoke detector(s). Most manufacturers recommend replacing smoke detectors after 10 years.

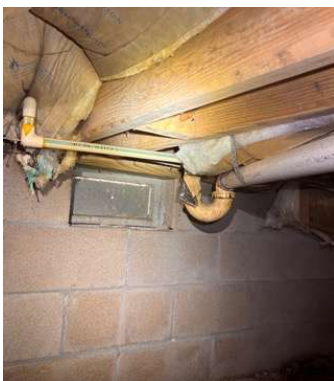
Location - Crawlspace

Sign(s) of previous leak(s). Monitor and repair as needed.

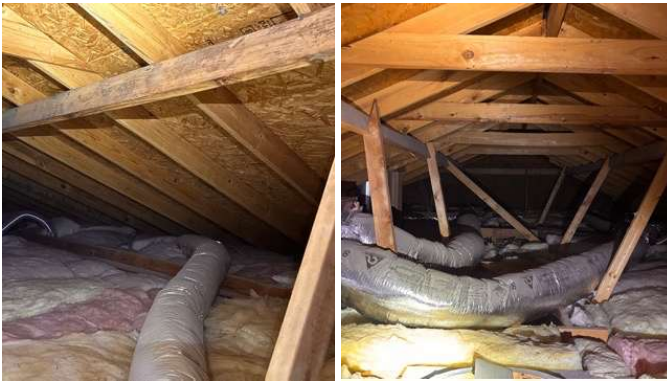
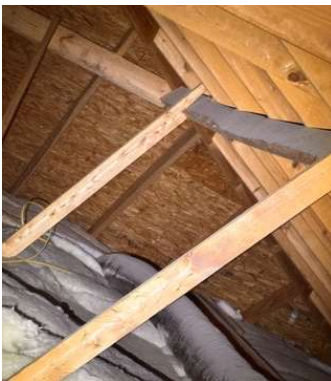
**Lack of support in roof area**

During the inspection, it was observed that the roof area lacks adequate support. This deficiency can lead to structural stress and potential failure over time. It is recommended that a licensed structural engineer or qualified roofing contractor be consulted to evaluate the issue and design the necessary reinforcements to ensure the roof's structural integrity and safety. Prompt attention to this matter is advised to prevent further complications.

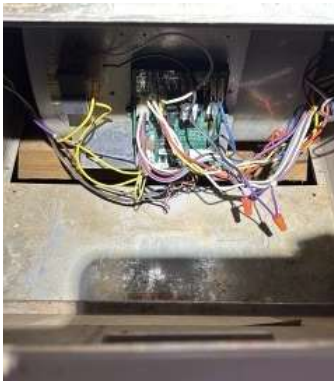
Filter missing

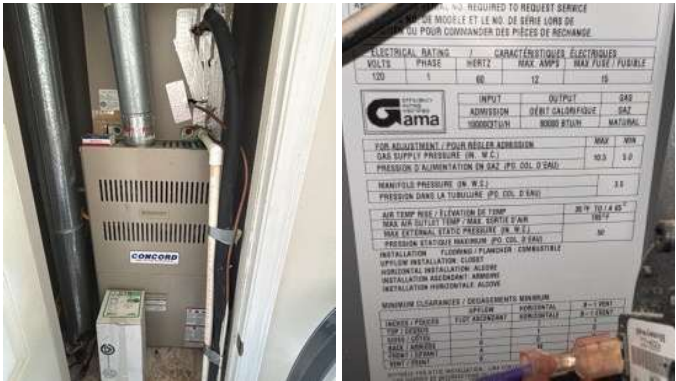
Leak found at top of blower unit

During the inspection, a leak was identified at the top of the blower unit in the cooling system. This may indicate a potential issue with the condensate line, drain pan, or other components.

It is recommended to have a licensed HVAC technician assess and repair the leak to prevent further damage and ensure optimal system performance. Periodic maintenance of the cooling system is also advised to identify and resolve any similar issues early.

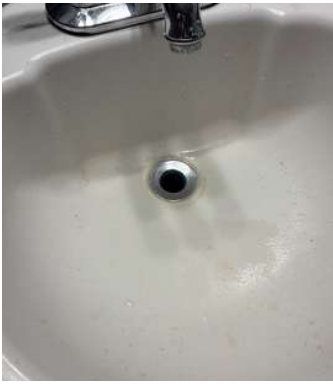
Stopper missing

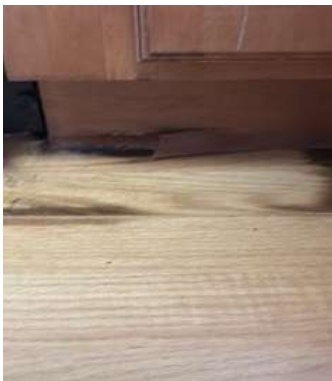
Water damage present under the counter

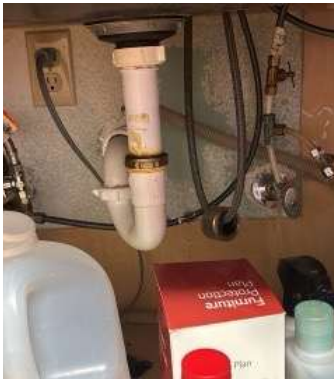
Water stain found

During the inspection, a water stain was observed near the dishwasher, indicating a possible leak. It is recommended to have a licensed plumber evaluate the situation to prevent potential water damage. Regular inspection and maintenance of the dishwasher seals and connections are advised to ensure optimal performance and mitigate future issues.

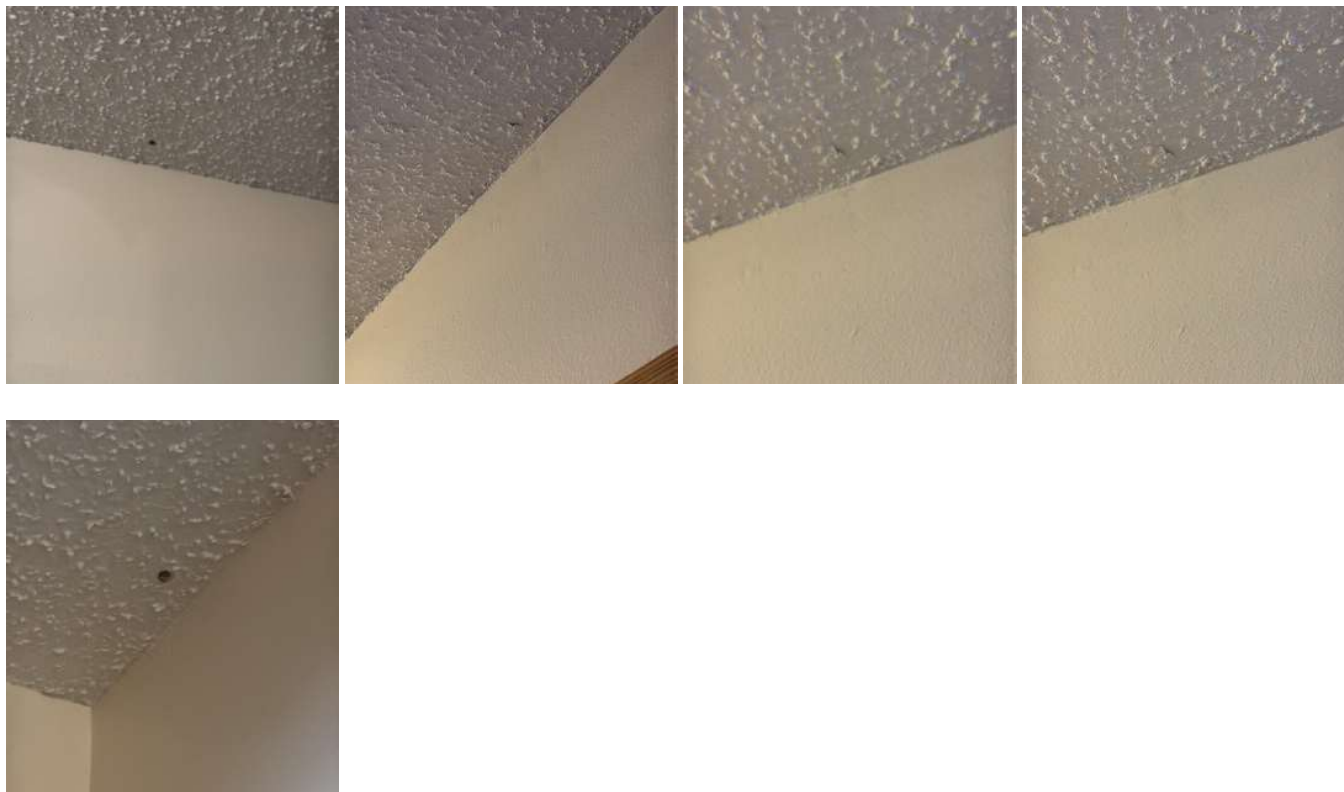
Nail pop(s) observed

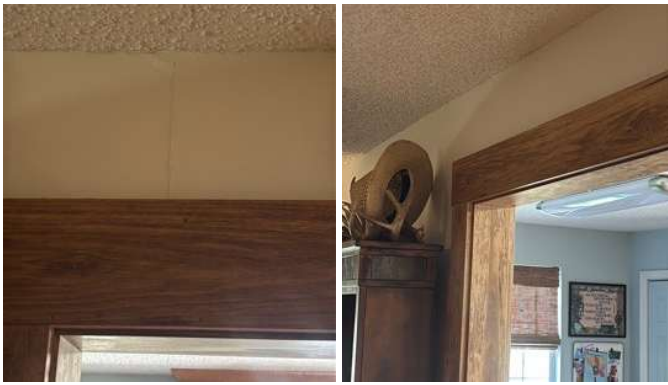
**Crack in wall vertical**

A vertical crack was observed in the wall, indicating potential foundation settling or structural movement. It's recommended to monitor the crack for any changes in size or appearance. Consulting with a structural engineer for further evaluation and guidance would be prudent to ensure structural integrity.

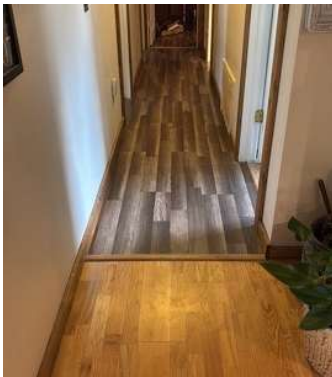
Uneven floor observed. Recommend that a qualified contractor evaluate and estimate repairs.

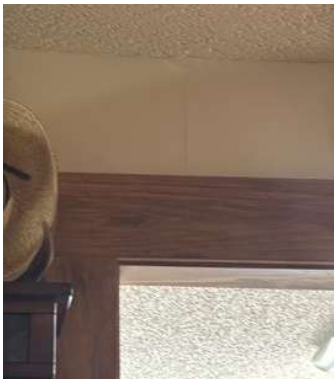
Typical cracking/flaws were observed in wall finish

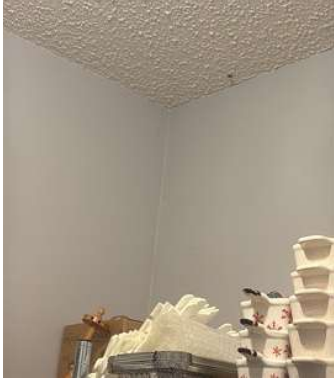
Wall(s) in closet has crack(s) not seen in room

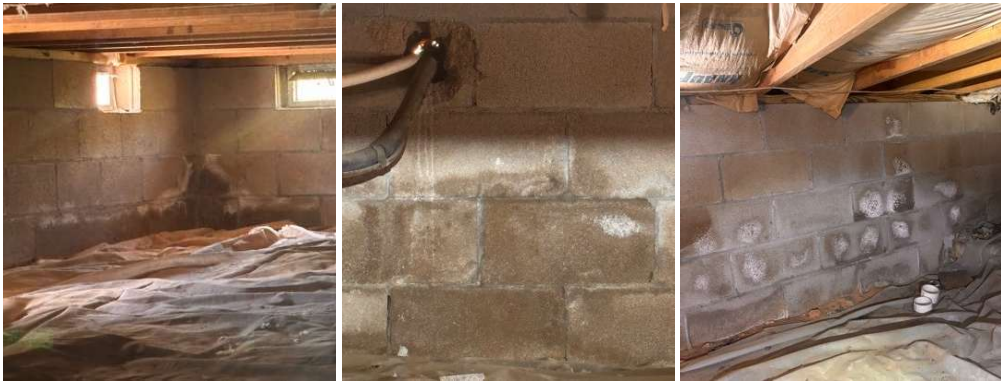
Efflorescence observed on crawl space walls indicates moisture intrusion. This typically results from groundwater or high humidity levels. Recommend further evaluation to identify the moisture source. Implementing improved drainage and ventilation systems may help mitigate future occurrences. Consider consulting a waterproofing professional for solutions.

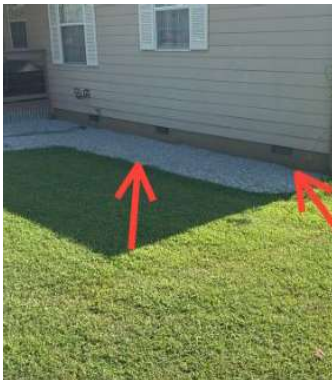
Location - Southwest

Improper slope is draining water towards the foundation which contributes to moisture and water penetration in the basement

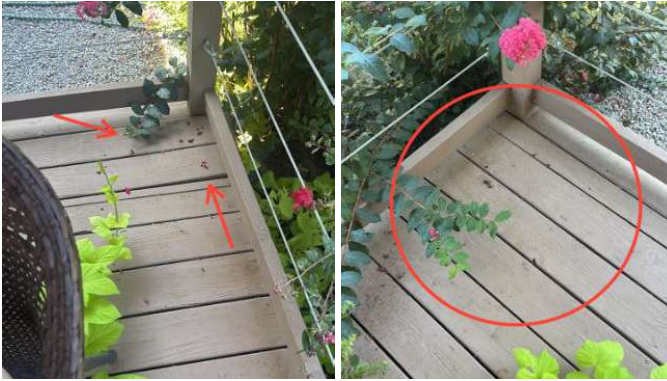
Location - West

## Trip hazard

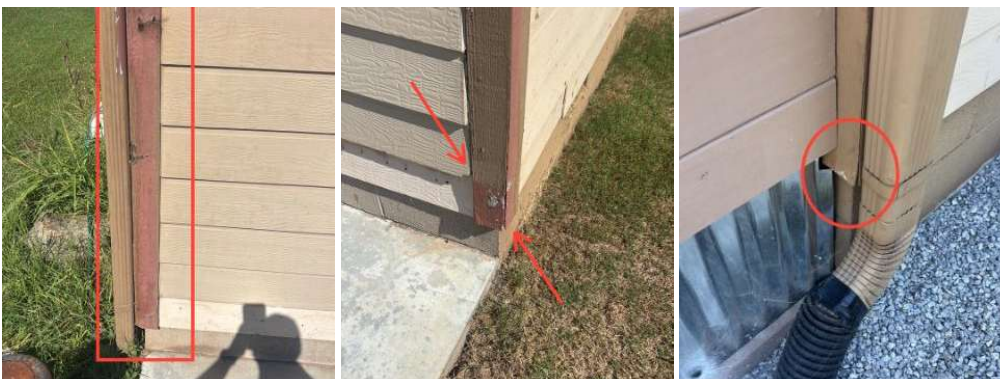
Location - Northwest, Southeast

Rot noted

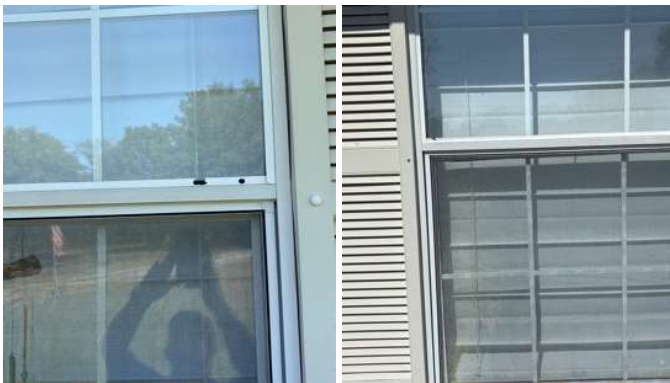
Location - East, West

Window seal broken or damaged

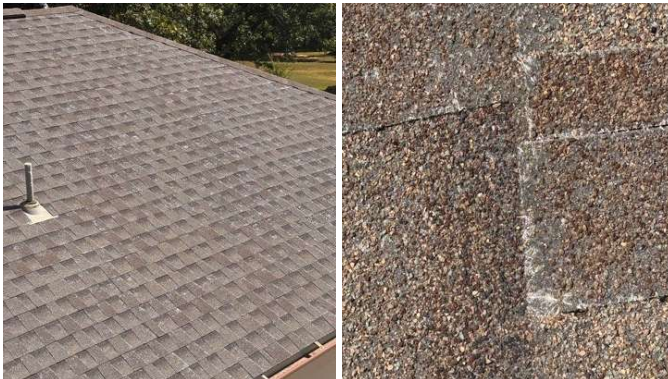
Roof at/near end of useful life

Recommend that a qualified contractor evaluate and estimate repairs

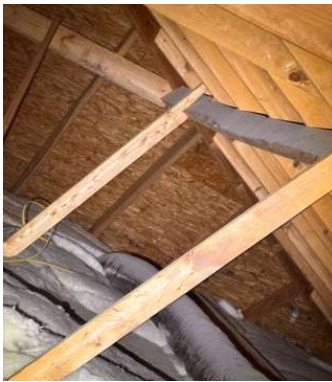
#### Lack of support in roof area

During the inspection, it was observed that the roof area lacks adequate support. This deficiency can lead to structural stress and potential failure over time. It is recommended that a licensed structural engineer or qualified roofing contractor be consulted to evaluate the issue and design the necessary reinforcements to ensure the roof's structural integrity and safety. Prompt attention to this matter is advised to prevent further complications.

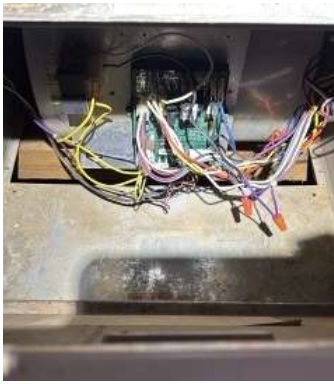
#### Filter missing

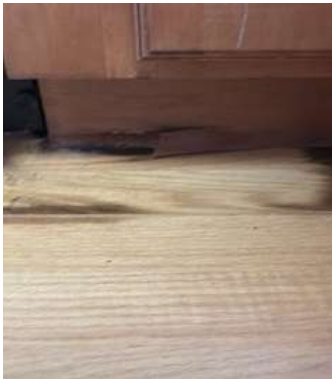
Water damage present under the counter

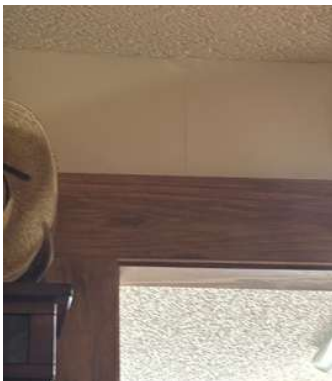
Typical cracking/flaws were observed in wall finish
