Aug 21st, 2025

# Home Inspection Report

Corey Hinson / Cornerstone Home Inspections

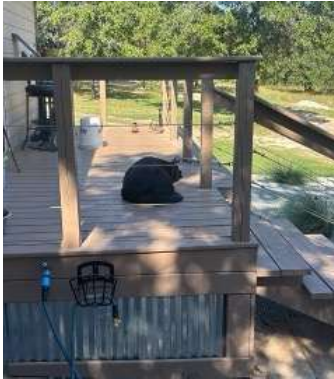
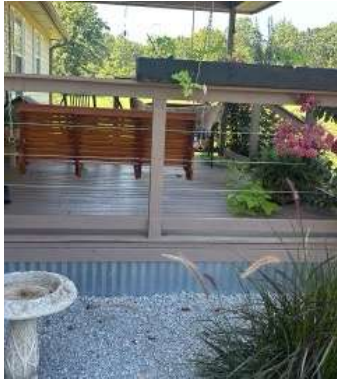
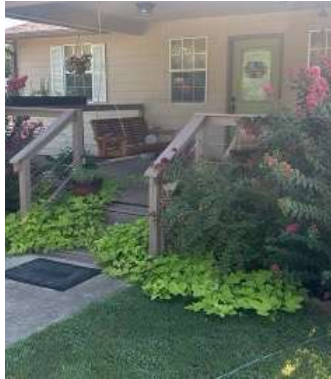
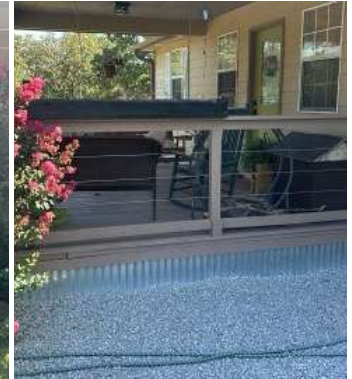
**LOCATION:** West, North

Boards are no longer fastened to structure

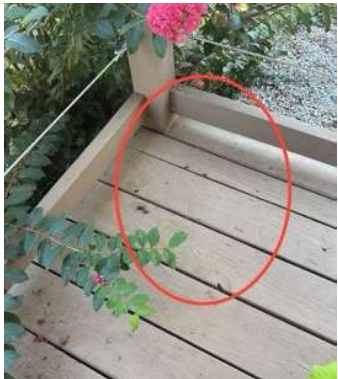
Boards are no longer fastened to structure

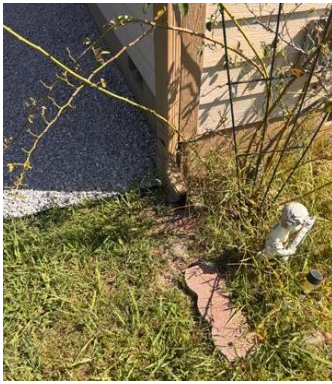
LOCATION: Southwest

**Damaged**

The downspouts/leaders/extensions are damaged, potentially impacting proper water drainage. Recommend repair or replacement by a qualified professional to prevent water accumulation and potential foundation issues.

Extend drain(s) to move water away from foundation

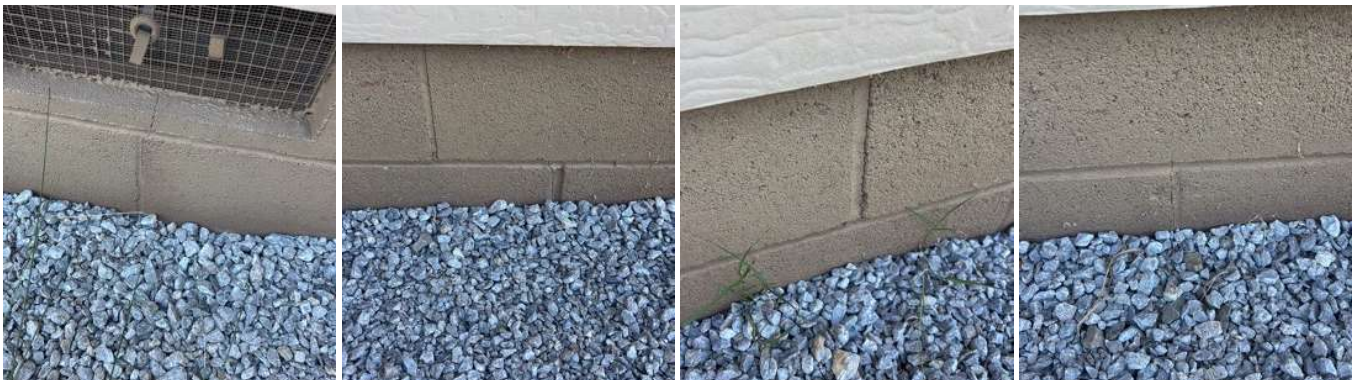
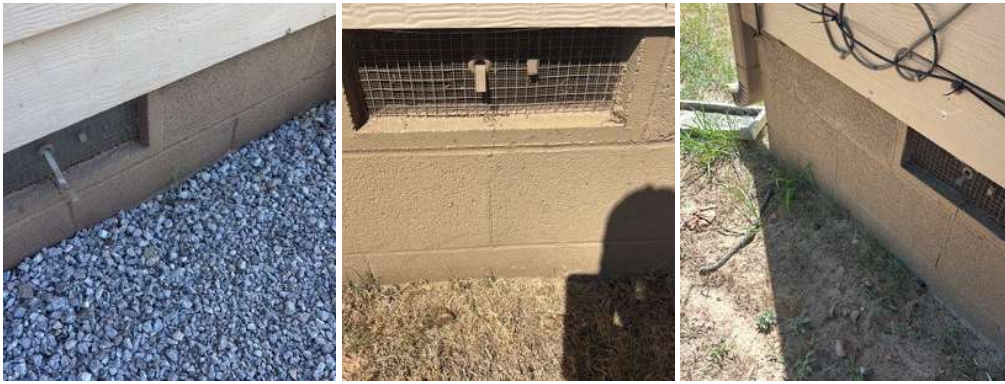
Cracks present but not active

During the inspection, non-active cracks were observed in the foundation. These do not appear to currently indicate any structural issues. It is recommended to monitor these cracks over time for any changes or signs of movement. Consult a structural engineer if any crack activity is noted in the future for a detailed assessment. Regular maintenance and moisture management can help prevent further cracking.

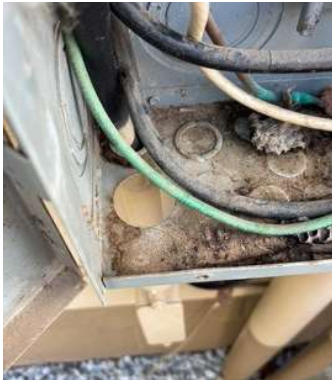
Open knockout hole. Insert blank to cover opening.

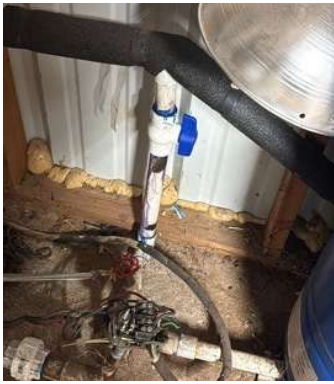
Location - Pump House

The valve was not operated during the inspection

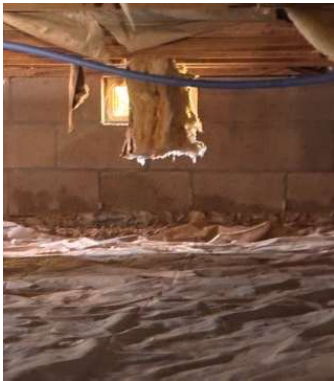
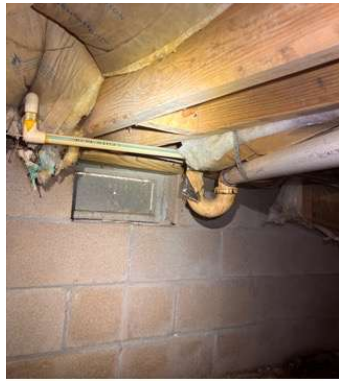
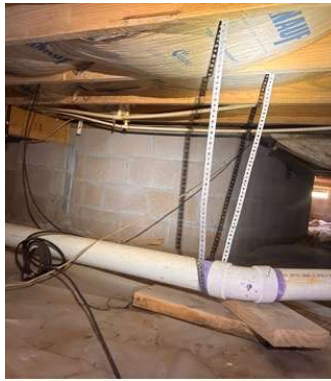
Sign(s) of previous leak(s). Monitor and repair as needed.

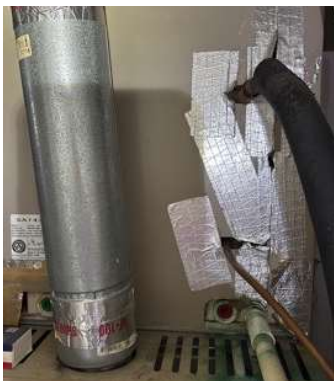
Location - Utility room

Seal penetrations in duct work

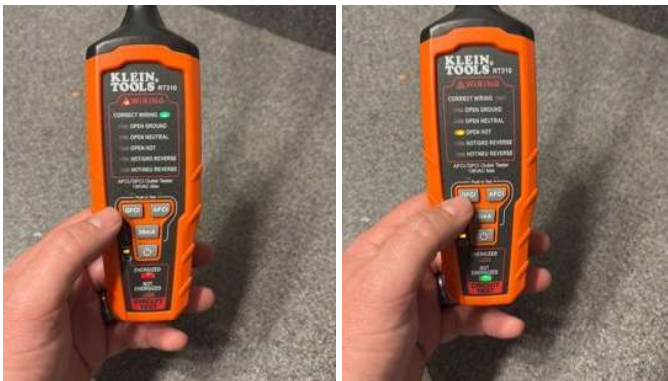
GFCI

GFCI outlets functioning properly; no defects observed.

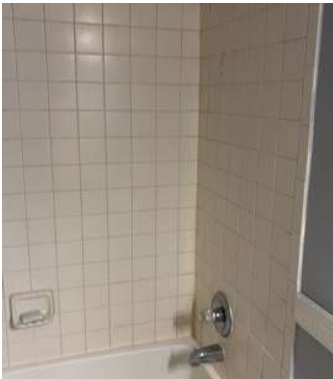
Shower not inspected

The shower was not inspected due to access restrictions at the time of the inspection. It is recommended to schedule a follow-up inspection to evaluate the shower's condition and ensure it is functioning properly.

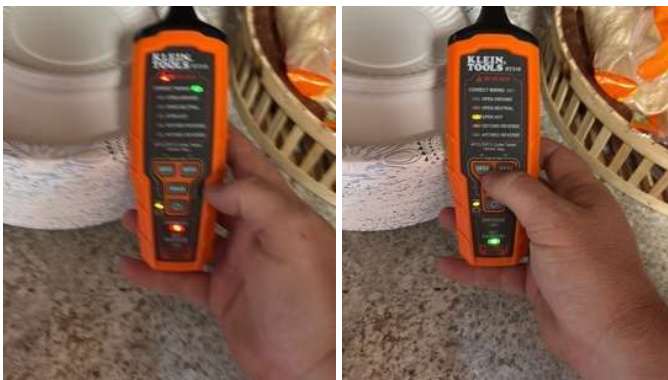
Outlets and GFCI inspected

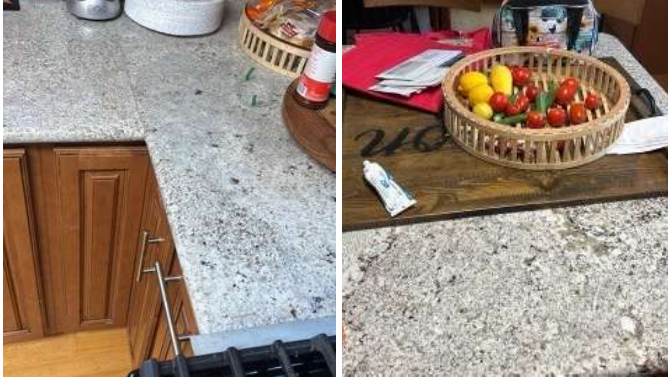
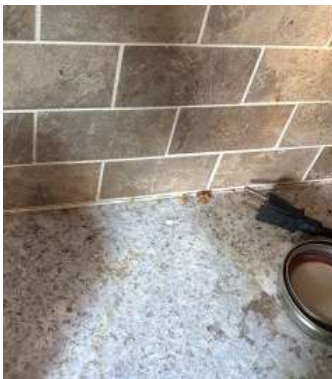
Caulk the edge(s) of the counter and backsplash

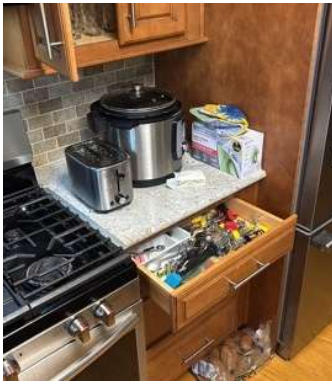
Operating as designed

Cabinets are functioning properly and show no signs of wear or damage.

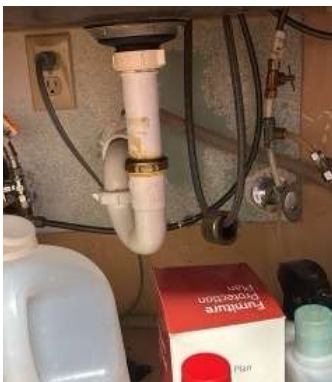
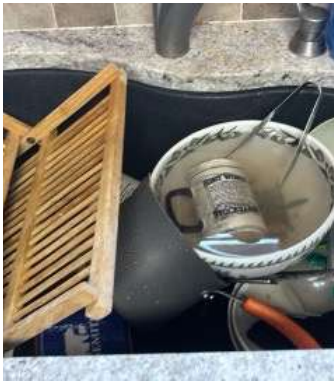
Sink not fully inspected due to dishes

Sink inspection limited; dishes obstructing full view. Under sink counter inspected no issues present at this time

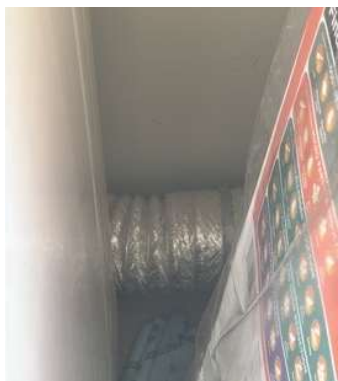
Recommend cleaning dryer vent

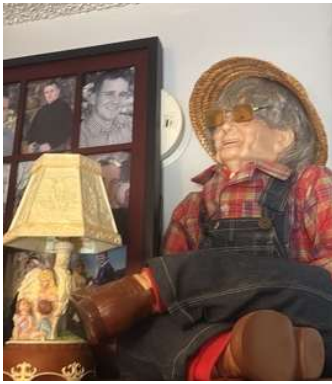
Smoke detector(s) were not tested

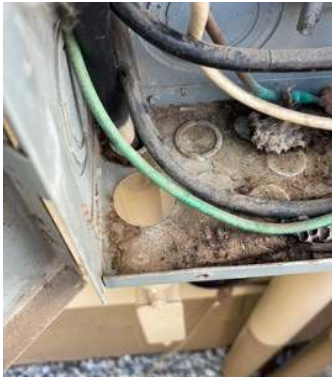
Open knockout hole. Insert blank to cover opening.

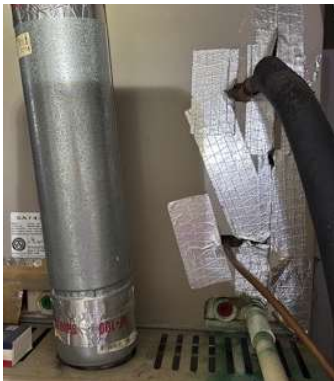
Location - Utility room

Seal penetrations in duct work

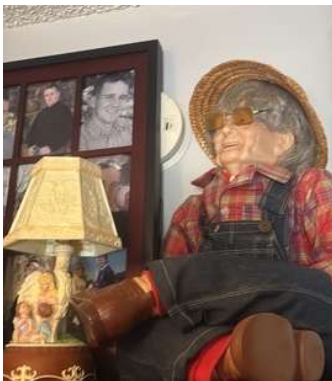
Smoke detector(s) were not tested
